National Register of Historic Places Registration Form

historic name Smith Farm

other names/site number Smith-Grundy Farm

Smith Farm, Hendricks County, Indiana

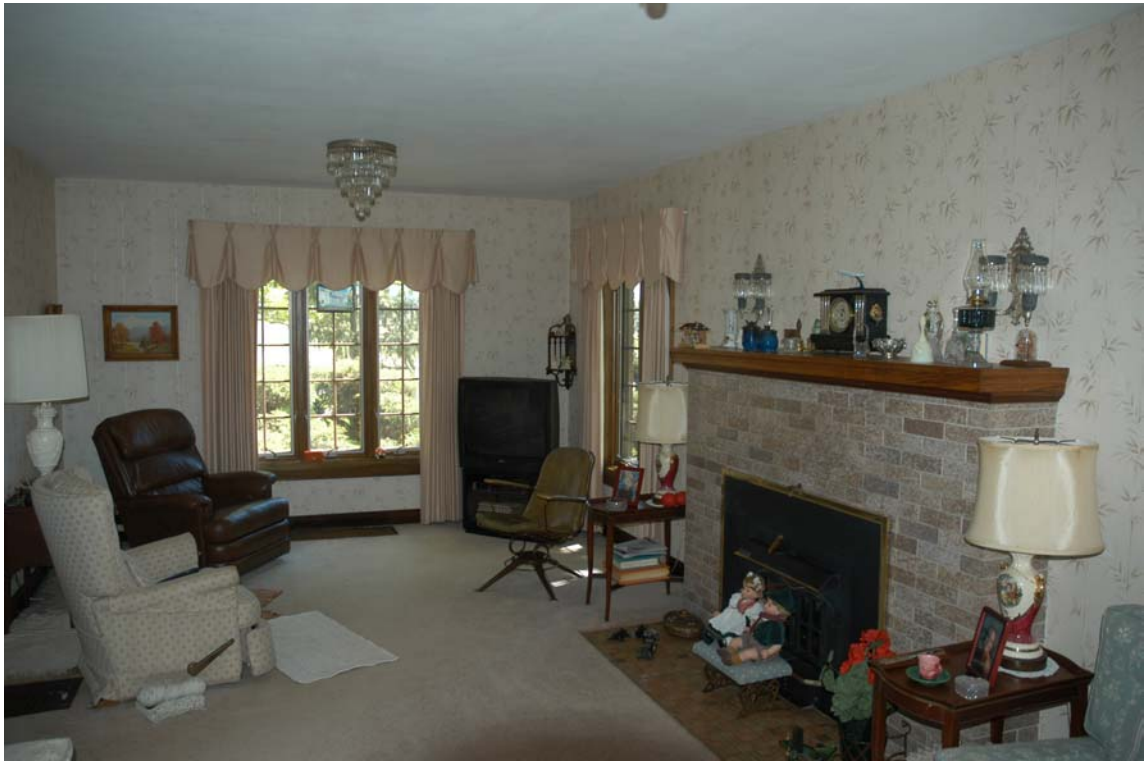
Photo 2

1. Smith Farm
2. Hendricks County, Indiana
3. Thomas M. Meredith
4. April 23, 2006
5. DHPA, 402 W. Washington Street, Rm W274, Indianapolis, Indiana 46204
6. Camera facing east, view of Living Room
7. Photo # 2

The interior is also basically simple in design with only a few decorative details. The entrance foyer is separated from the first floor hall by a 24 pane glass and lead came wood framed door (photo # 3). The floor material in the foyer is tile (photo #5). The same tile is used for the fireplace hearth (photo # 2). The fireplace surround and mantle are brick with a simple crown mold shaped wood cap. The brick is multi earth tones and does not match the exterior brick.

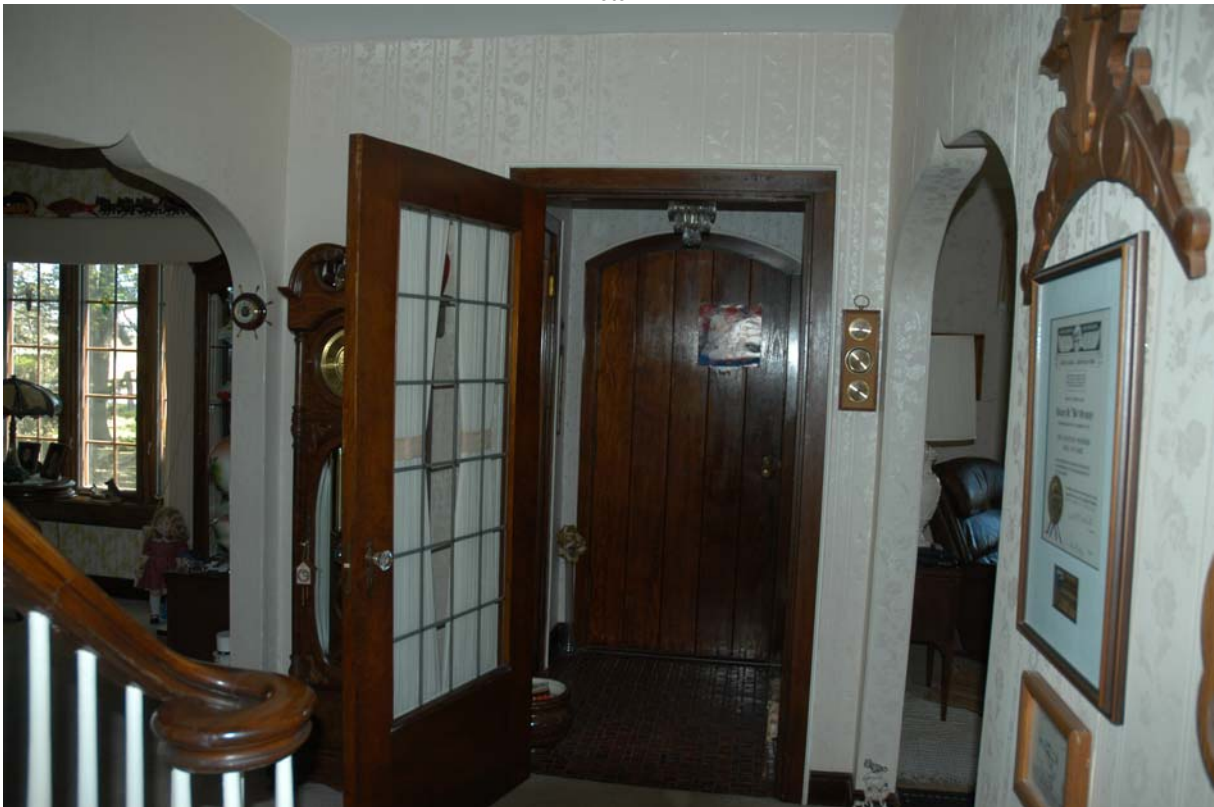
Photo 3

1. Smith Farm
2. Hendricks County, Indiana
3. Thomas M. Meredith
4. April 23, 2006
5. DHPA, 402 W. Washington Street, Rm W274, Indianapolis, Indiana 46204
6. Camera facing east, view of 1st Floor Hall and Entrance Foyer
7. Photo # 3

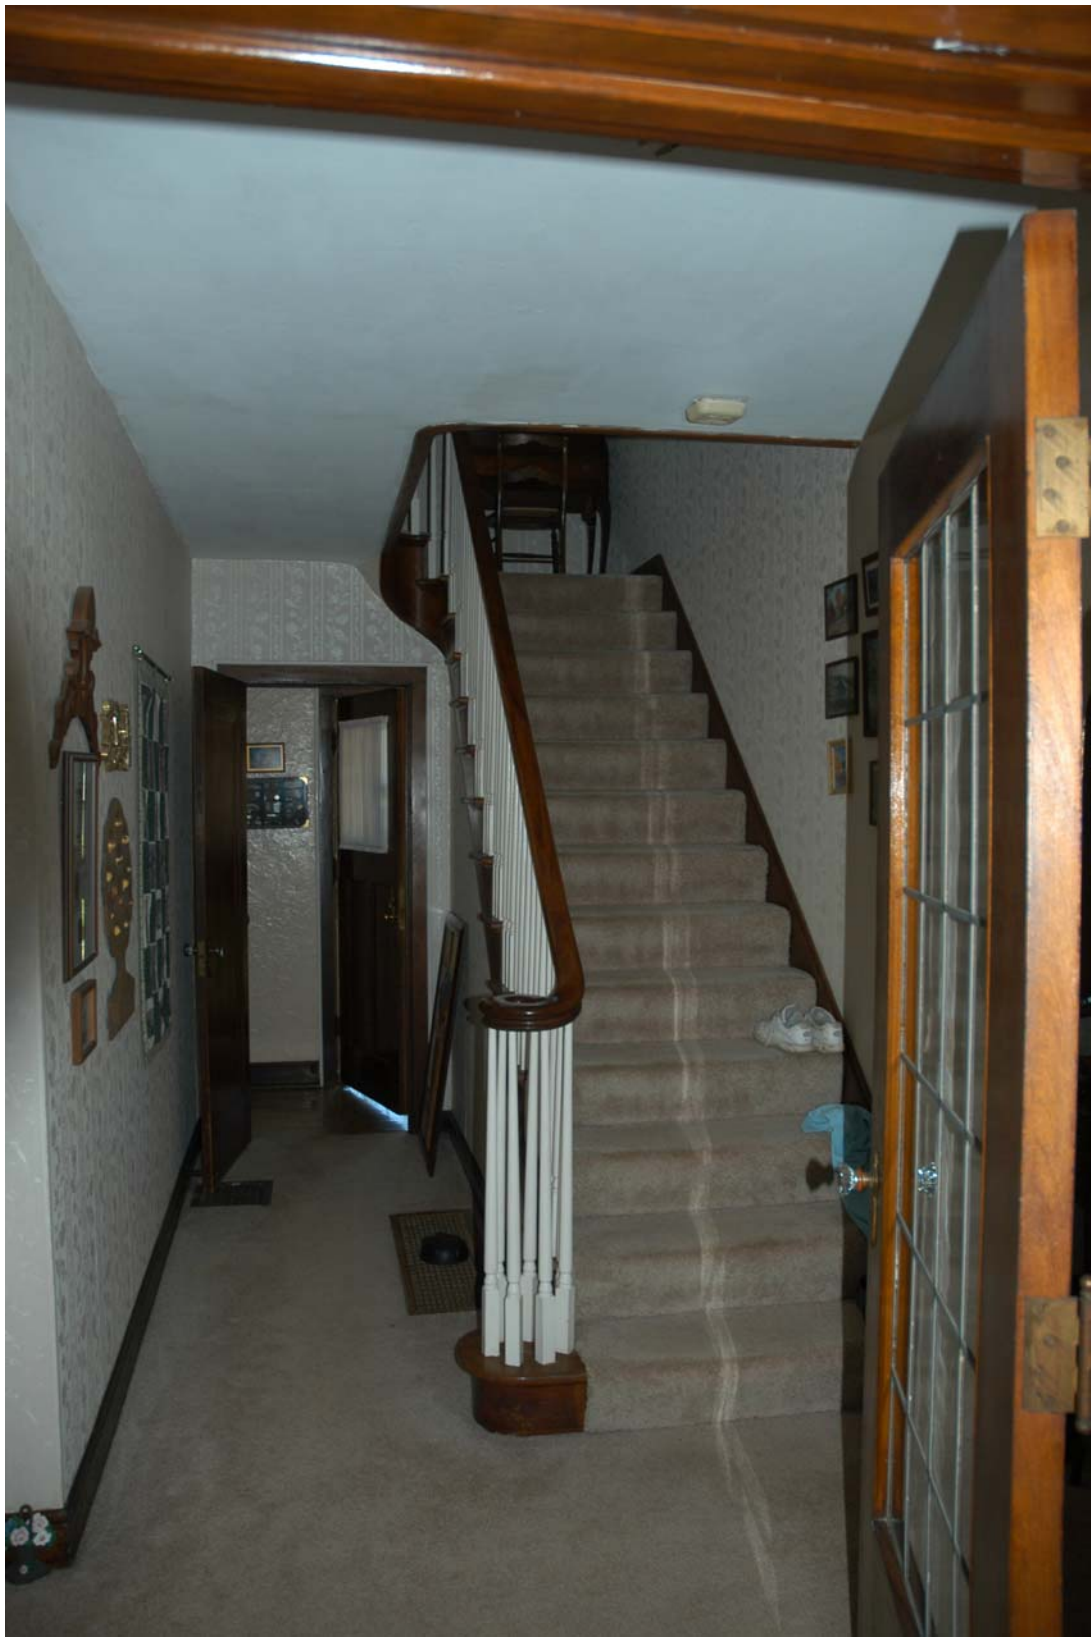
Photo 4

The staircase is Neo-Georgian with its continuous flowing handrail, simple balusters and a lack of a separate newel post (photo #4). It offers an elegant appeal to the hall even though it differs from the exterior Tudor style.

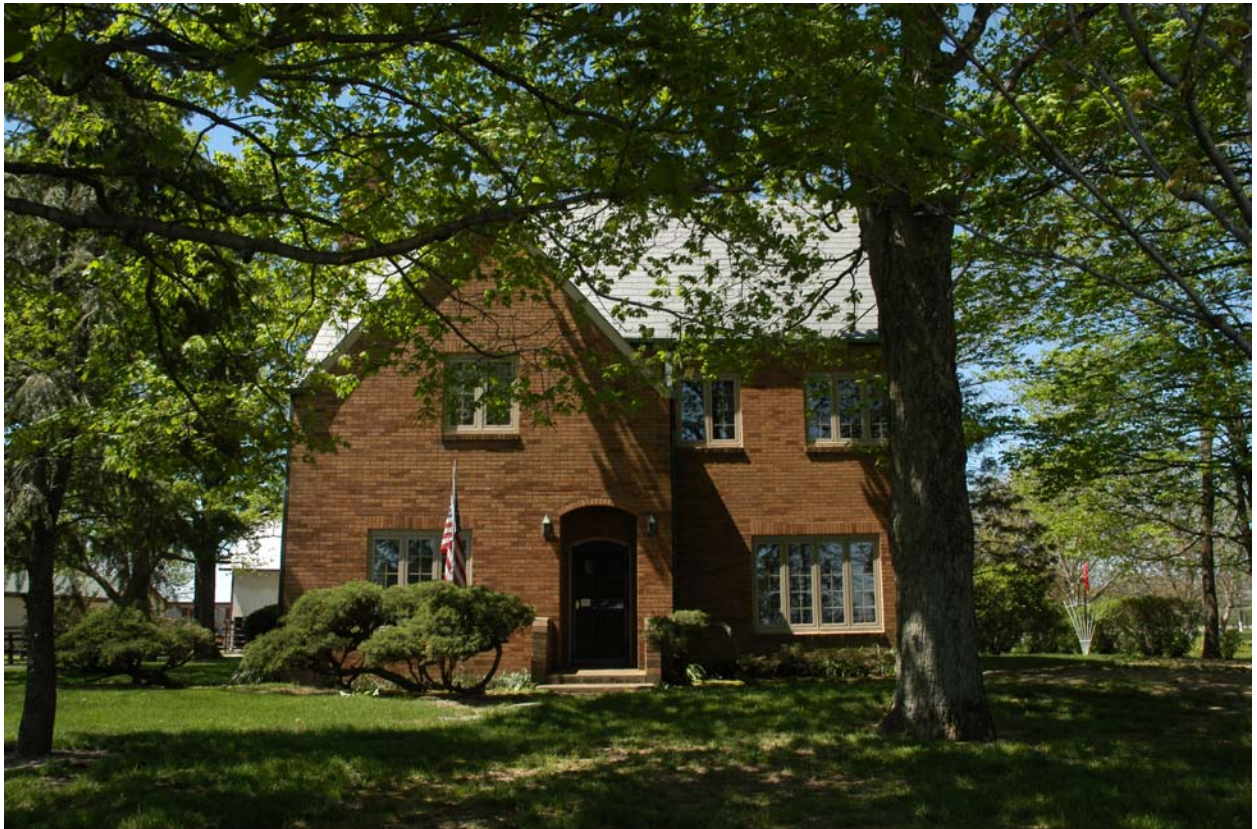
Photo 11

The east façade is the main entrance façade and faces the public street, County Road 900 East and sometimes referred to as Smith Road (photo # 11). The entrance door is located on the north side of the projecting gabled pavilion, set back from an arched opening in the brick façade. The entrance door is made from five wide vertical boards with a shallow arched top. Three tall narrow grouped multi light casement windows are placed to the south side of the east façade on the first floor. These windows open to the living room. On the second floor is a pair of multi light casement windows, grouped and narrow but not as tall as the first floor windows. These windows open to the sitting room for the master bedroom on the second floor. It is centered on the façade. To the north of the projecting pavilion, and on the first floor, are four tall narrow grouped multi light casement windows. These windows open into the dining room and are the same size as the windows in the living room. The second floor has two sets of grouped windows. To the south is a pair of grouped multi light casement windows and to the north is a set of three grouped multi light casement windows. These windows open into another bedroom. These are the same size as the other second floor bedroom windows and are narrow but not as tall as the first floor windows.

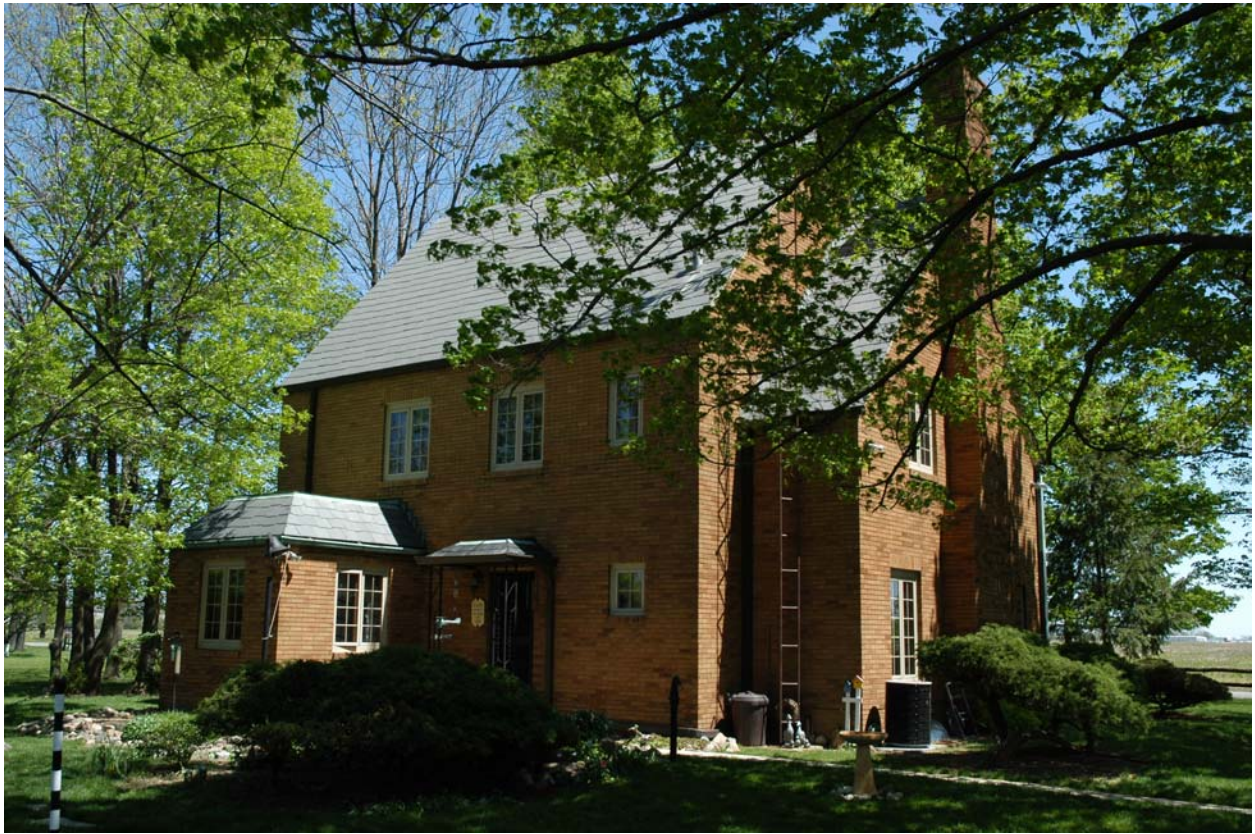
Photo 13

The west façade has a single story projection for the breakfast room, directly off the kitchen (photo #13). It has a modified mansard roof with gray slate shingles and a flat top. The three exposed sides of this room each have a pair of grouped multi light casement windows, same size as the second floor windows. In the center of the west façade is the rear door. It has a small roof structure, with imitation wrought iron posts at both outside corners, that was added in 1981. The door is wood, painted with two vertical panels on the lower 2/3's and 8 light glass and lead came fixed window in the top portion. To the south of the rear door is a single multi light casement window, opening into the first floor half bath. This window is identical to the attic window on the north façade. Directly above the first floor half bath is a full bath. It has a single multi light casement window which is narrow but not as tall as the typical second floor casement windows. Directly above the rear door and almost centered on the west façade is a pair of grouped multi light casement windows, which opens to the second floor hall. To the north of this window is another pair of grouped multi light casement windows, which opens to the third bedroom located in the northwest corner of the second floor. These windows are identical to the other second floor bedroom windows and the second floor hall window.

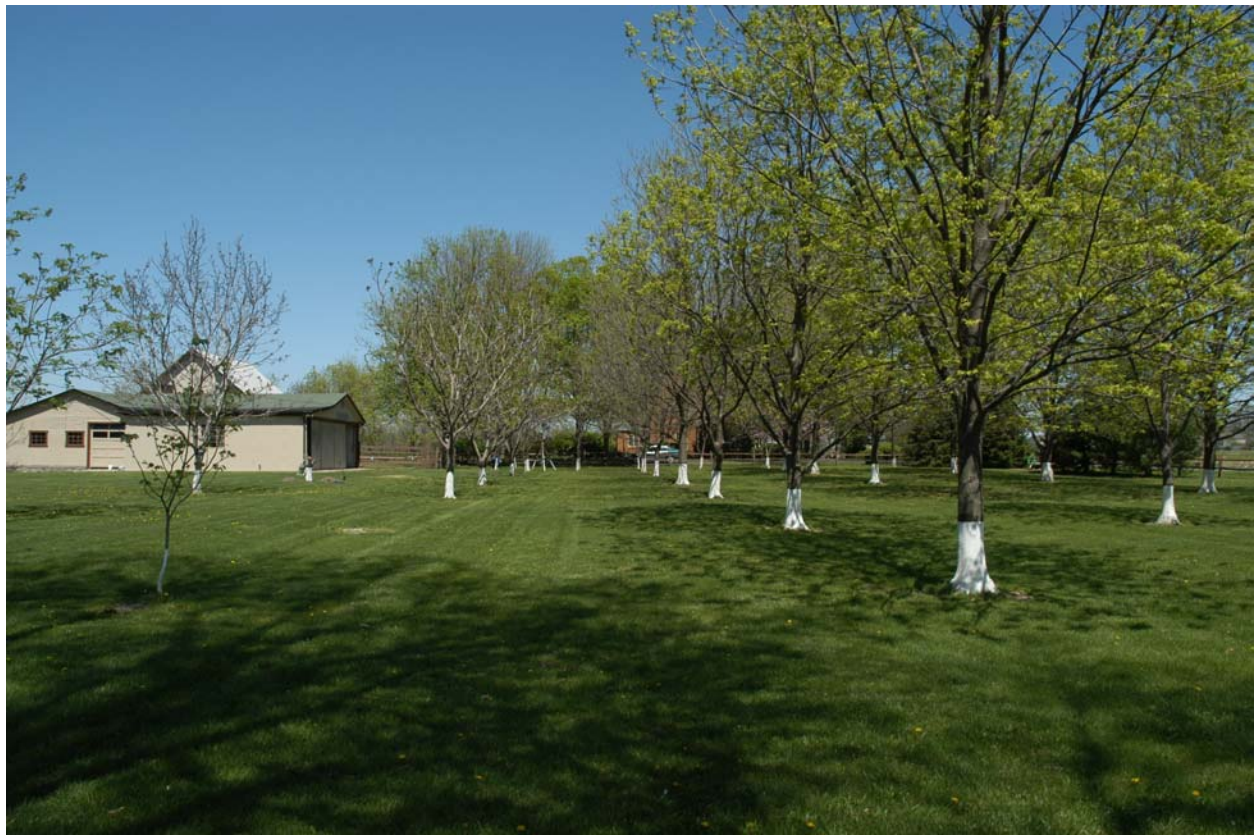
Photo 19

Also, there are three recent metal silos on the property. All of these outbuildings are in good to excellent condition. The orchard of pecan, heartnut, English walnut and persimmon trees was planted after 1970 when Robert Grundy, the current owner, retired from farming (photo # 19). The silos are counted as noncontributing structures; the orchard is counted as a noncontributing site and the field for crops is not in boundary, as indicated in Section 5, Classification/Number of Resources within Property.

1. Smith Farm
2. Hendricks County, Indiana
3. Thomas M. Meredith
4. April 23, 2006
5. DHPA, 402 W. Washington Street, Rm W274, Indianapolis, Indiana 46204
6. Camera facing north, view of Orchard and Cattle Barn
7. Photo # 19
